NBSIR 75-671

# Examination of Piston Rod and Rod End From DC-8 Main Landing Gear Retract Cylinder Assembly

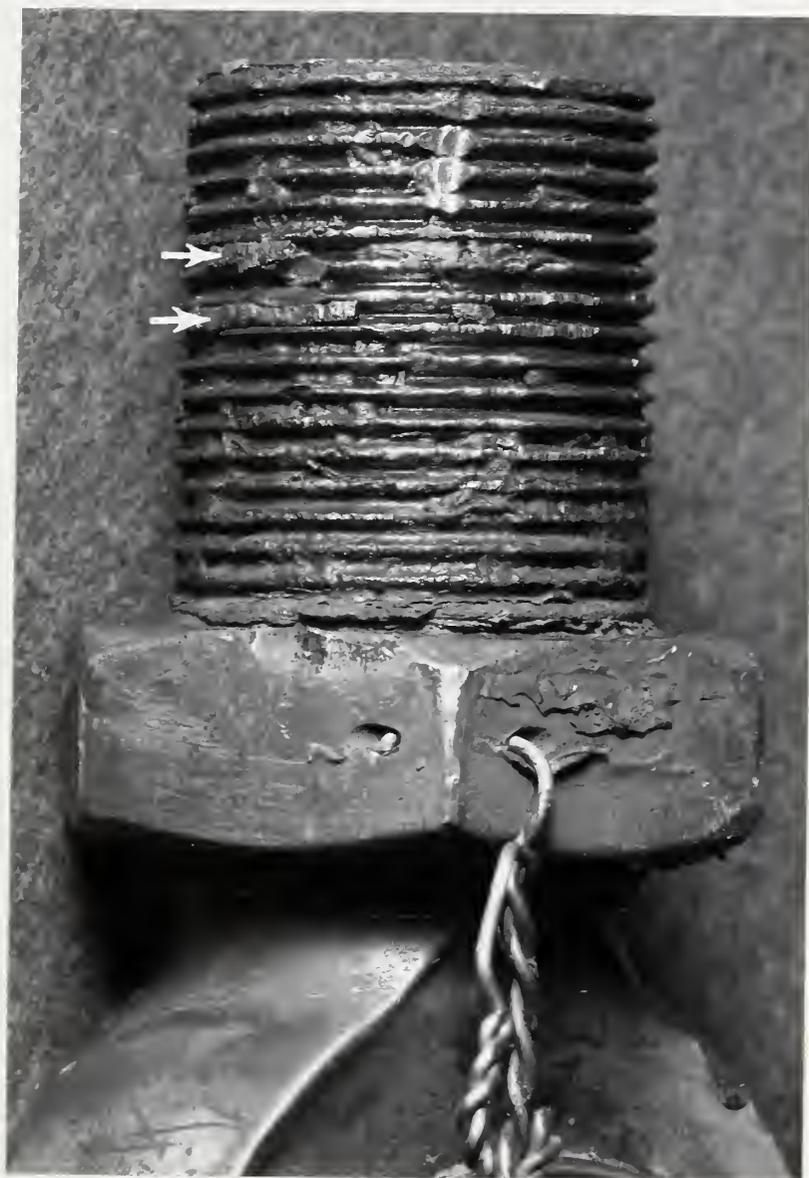
Figure 2. View of the rod end as received. Thread damage is evident. Parts of some of the threads of the mating piston rod can be seen. Arrows indicate examples of regions where parts of threads from the mating piston rod are still attached. X2

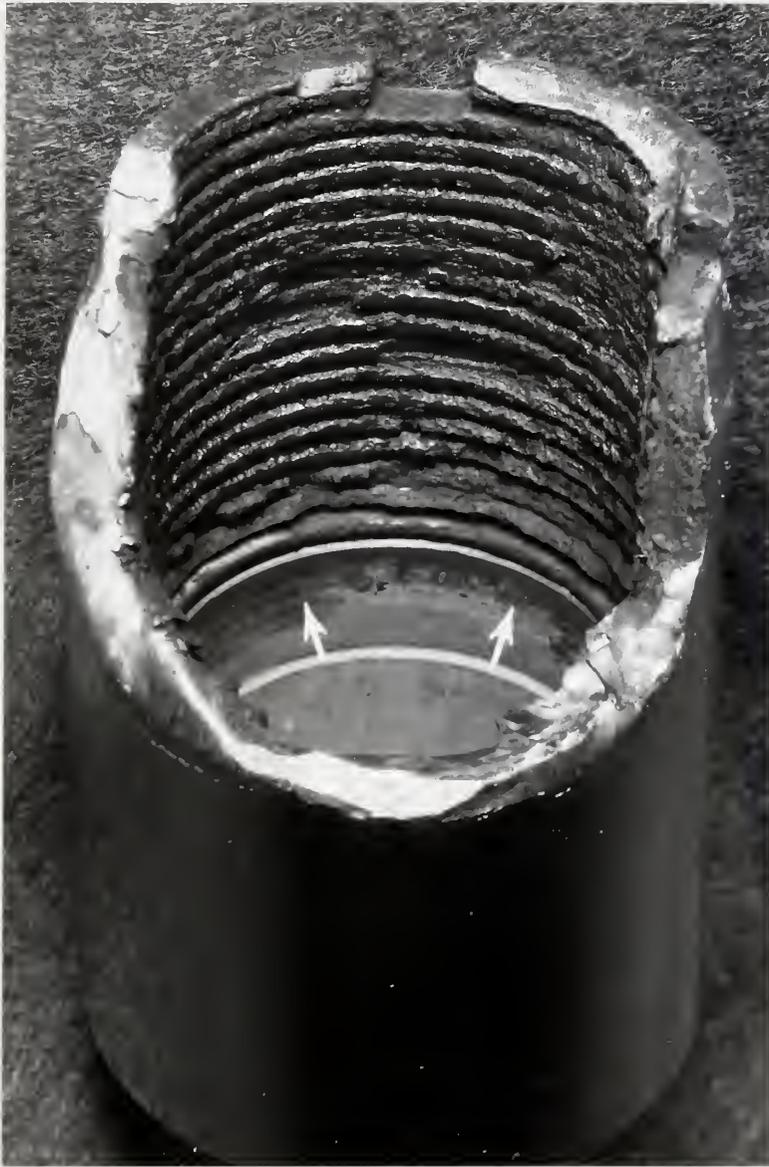
Figure 3. View of the piston rod as received. The fracture surface and portions of the corroded and damaged threads can be seen. The arrows indicate the approximate location of a transverse plane through the rod beyond which there is essentially no corrosion product. X2

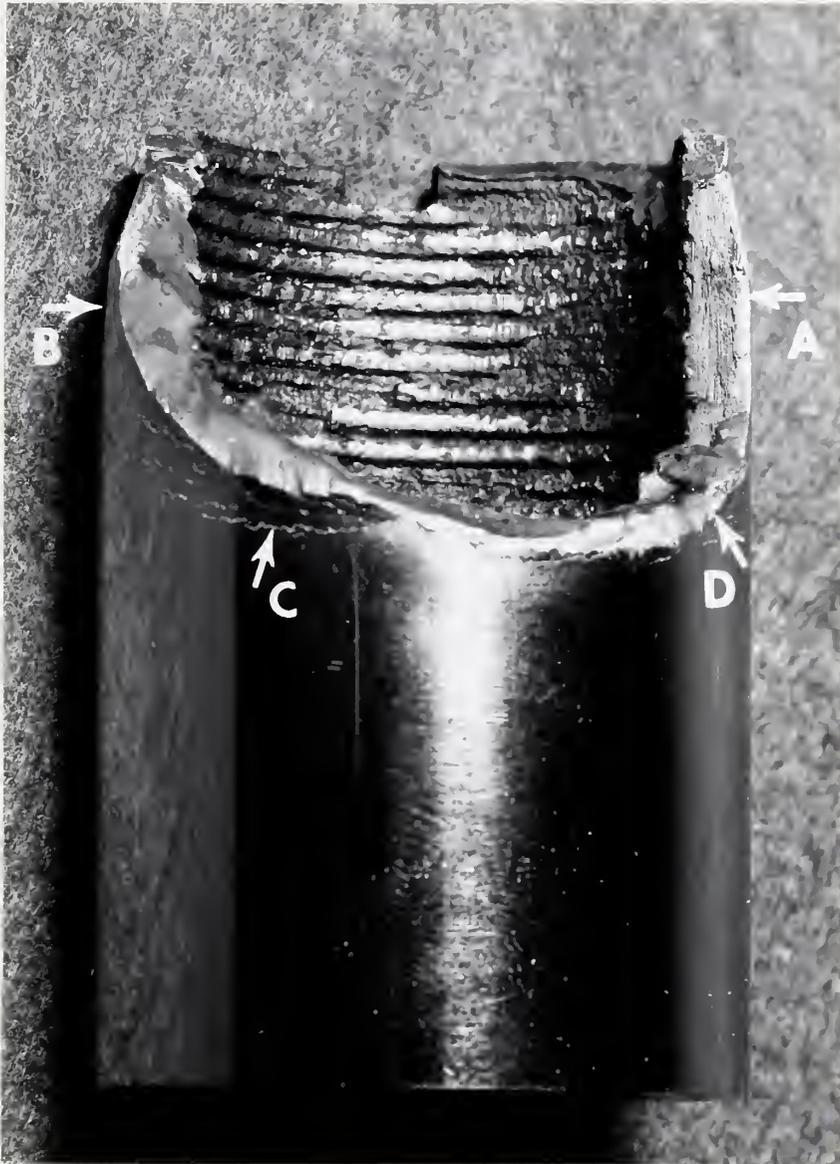
Figure 4. View of the piston rod as received showing most of the fracture surface. Except for the longitudinal part of the fracture (arrow A), the fracture surface was rather severely damaged. Arrow B indicates a region of macroscopic deformation. Arrow C indicates an example of cracks in the chromium plating. There is a pronounced lip along the fracture extending approximately from C to D. X2

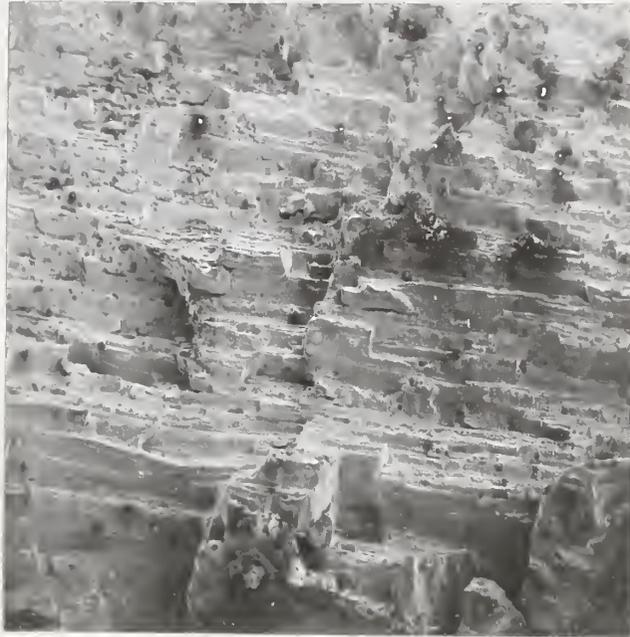
Figure 5. Scanning electron fractograph showing part of the undamaged fracture surface in the area designated by arrow B in figure 4. The longitudinal axis of the piston rod is horizontal. X17

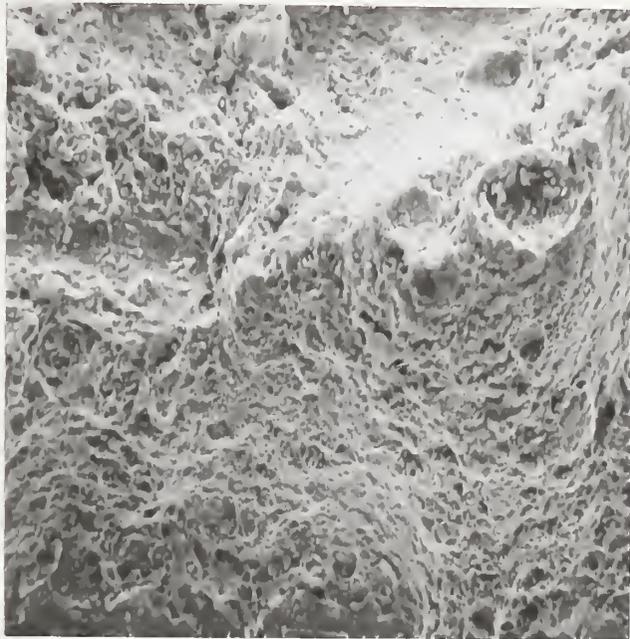
Figure 6. Scanning electron fractograph showing a typical area of the undamaged part of the fracture surface of the piston rod. The primary feature exhibited is dimpled rupture. X825

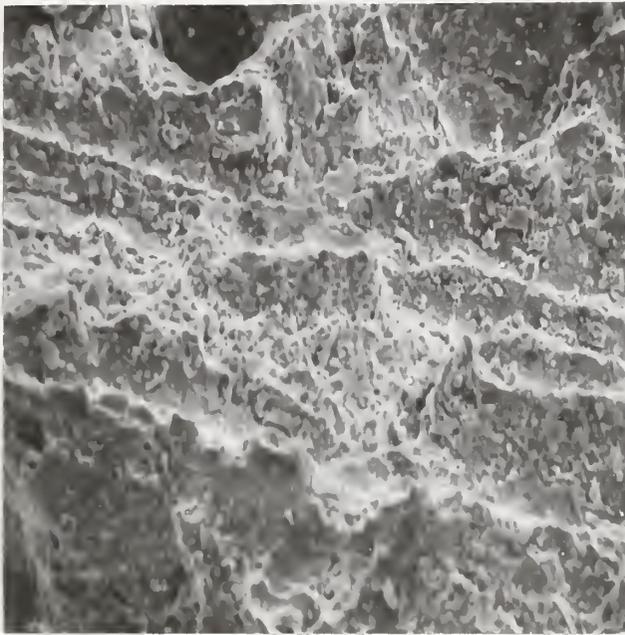
Figure 7. Scanning electron fractograph showing a typical area of the piston rod fracture surface. The primary feature exhibited is dimpled rupture. There may be some corrosion product on the surface. There is some evidence of the "layered" appearance that can be seen in figure 5. X825

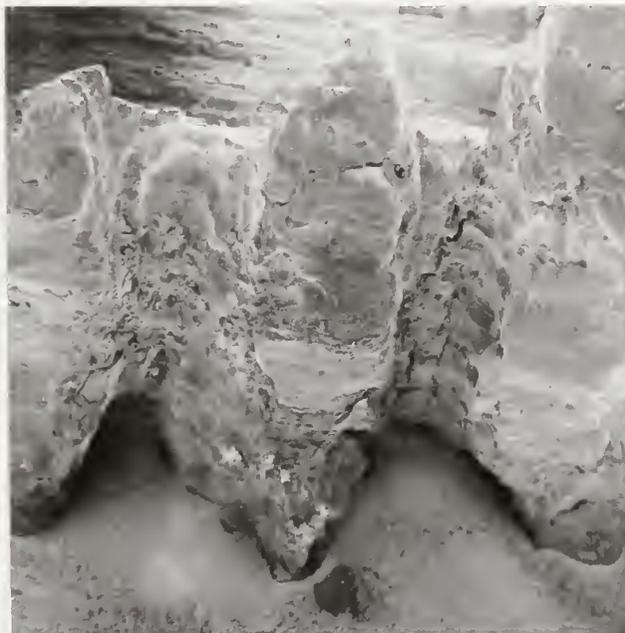
Figure 8. Scanning electron fractograph where the fracture intersects the threads. Mechanical damage and the deteriorated condition of the threads are evident. X18

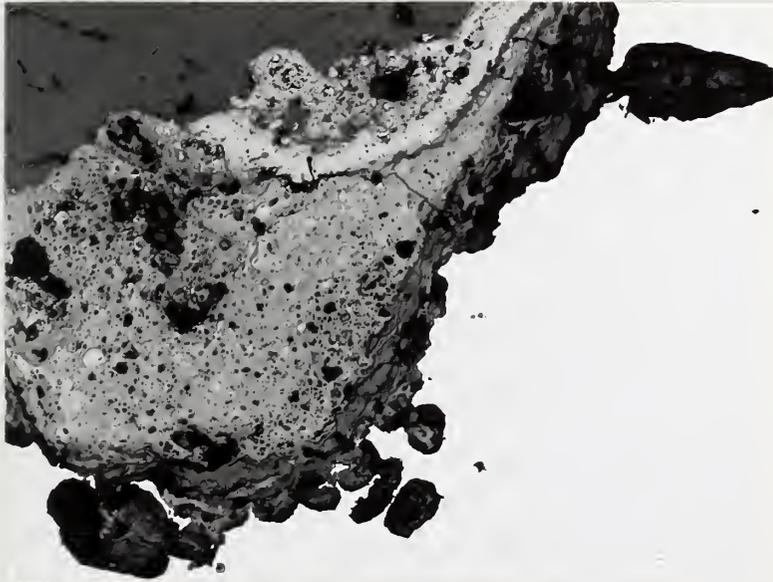
- a. Area apparently opposite the keyway in the mating rod end. The threads are corroded, but do not appear to be mechanically damaged.
- b. Area not opposite the keyway in the mating rod end. Threads are both corroded and mechanically damaged.

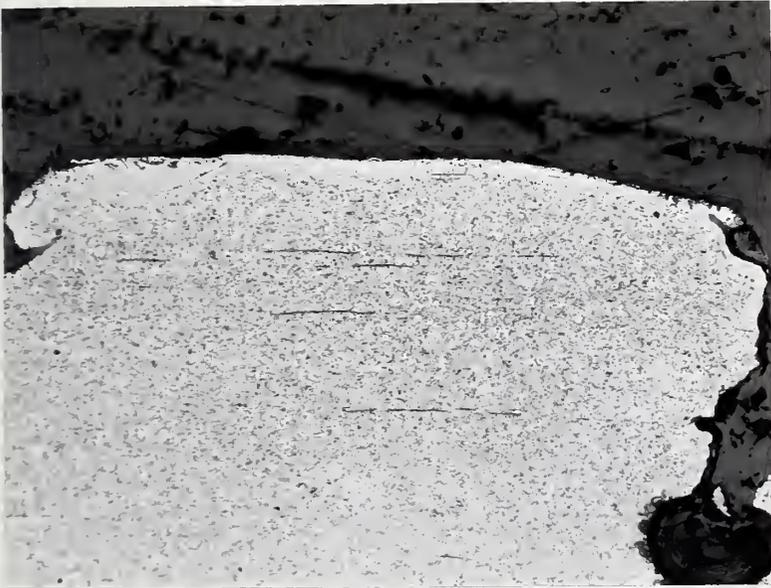
Figure 11. Etched longitudinal section through piston rod away from the fracture showing part of one thread (left). Deformation is evident at the tip. Etchant: 4% picral X80

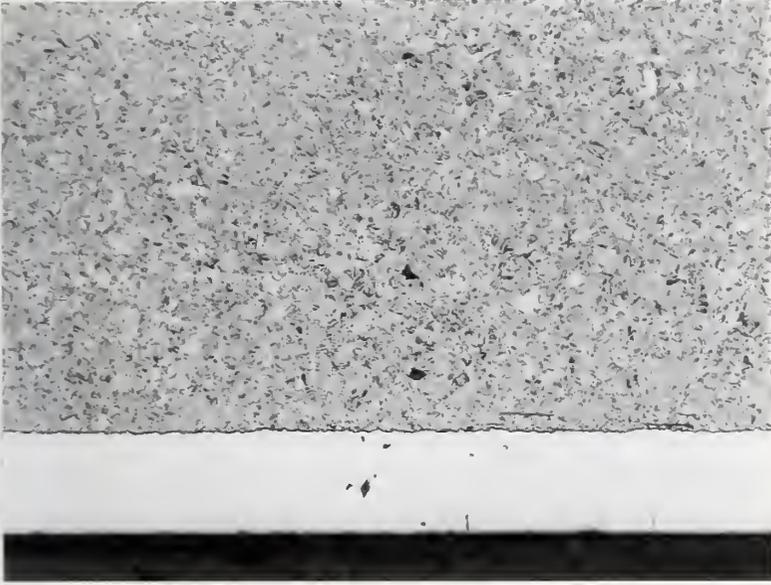
Figure 12. Etched longitudinal section through piston rod away from fracture. The chromium plating on the outside surface of the rod is the light layer at the left. The microstructure consists of tempered martensite. Etchant: 4% picral X200

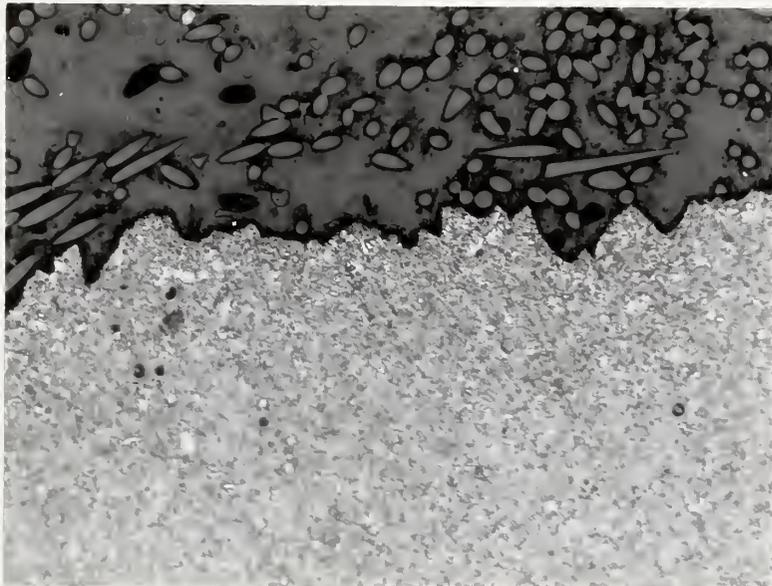
Figure 13. Longitudinal section through the piston rod showing the fracture profile in an undamaged region of the fracture.  
Etchant: 4% picral X200

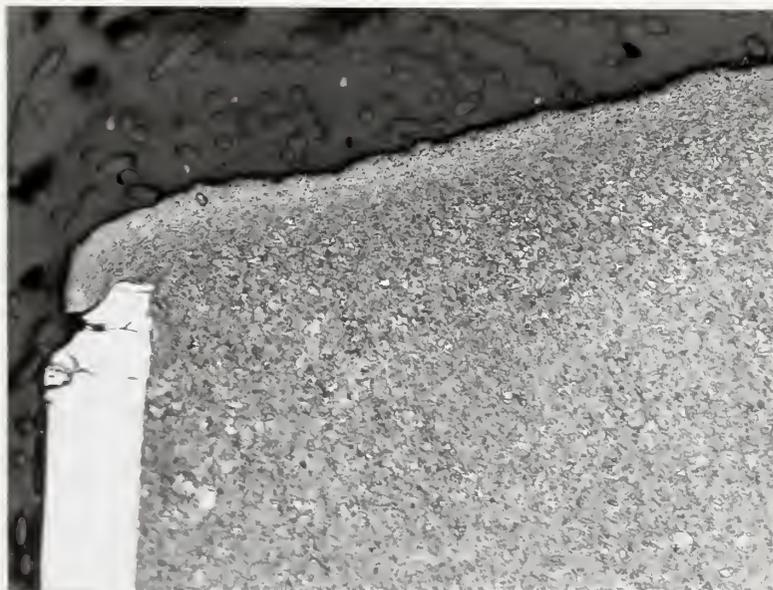
Figure 14. Longitudinal section through the piston rod showing the fracture profile adjacent to the outside surface in a mechanically damaged region of the fracture.  
Etchant: 4% picral X200

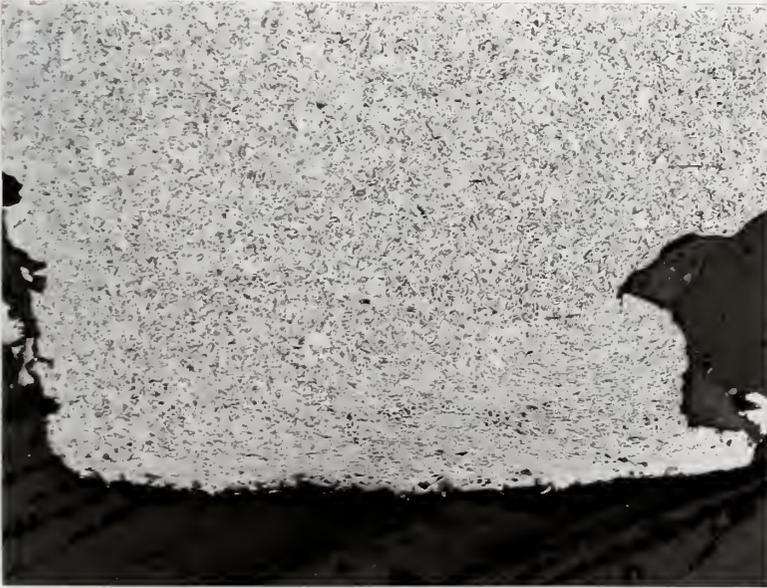
Figure 18. Etched longitudinal section through the rod end showing part of one of the threads. Deformation is evident. Etchant: 4% picral X100

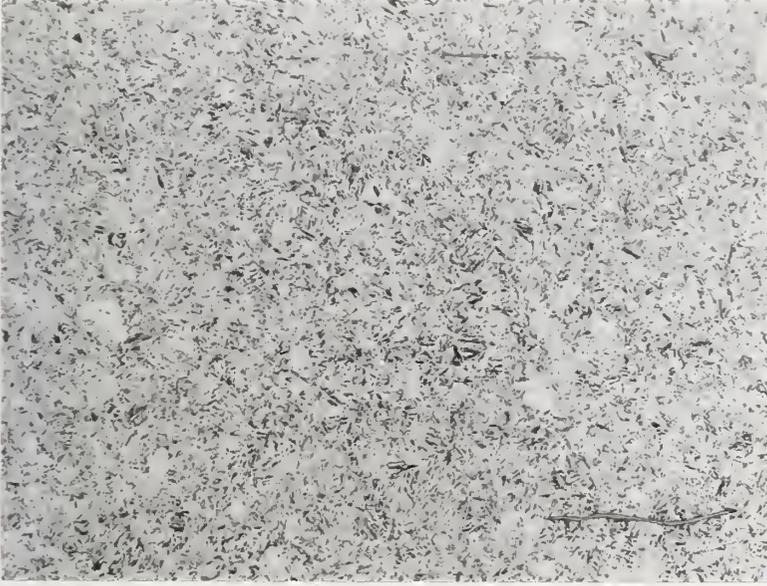
Figure 19. Etched longitudinal section through the rod end showing typical microstructure. The microstructure consists primarily of tempered martensite. Etchant: 4% picral X200
